Riverside - 10-story Office Bldg CGS Sta 13415

Rcd of Fri Jun 10, 2016 01:04:42.0 PDT

CISN/CSMIP Preliminary Strong Motion Processing - Subject to Revision

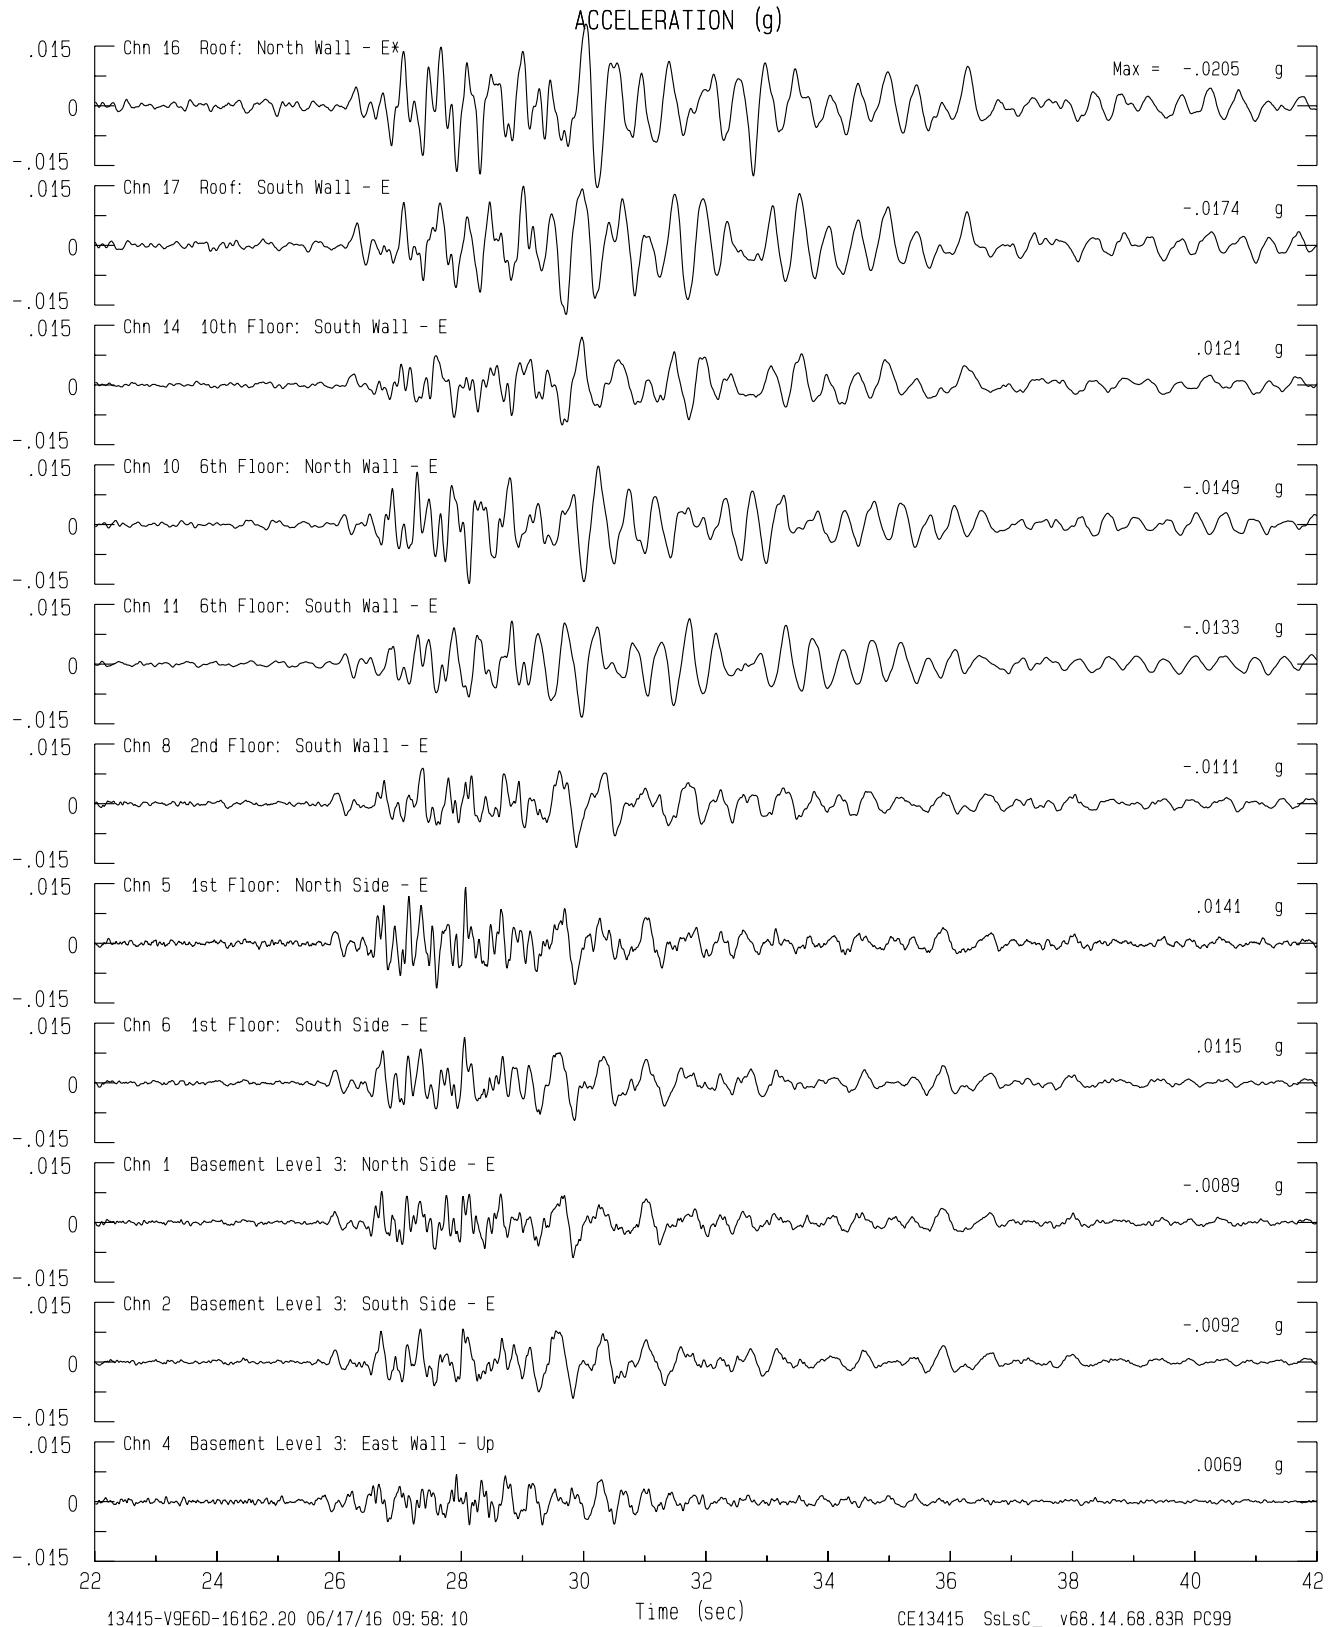
Frequency Band Processed: 3.3 secs to 40.0 Hz

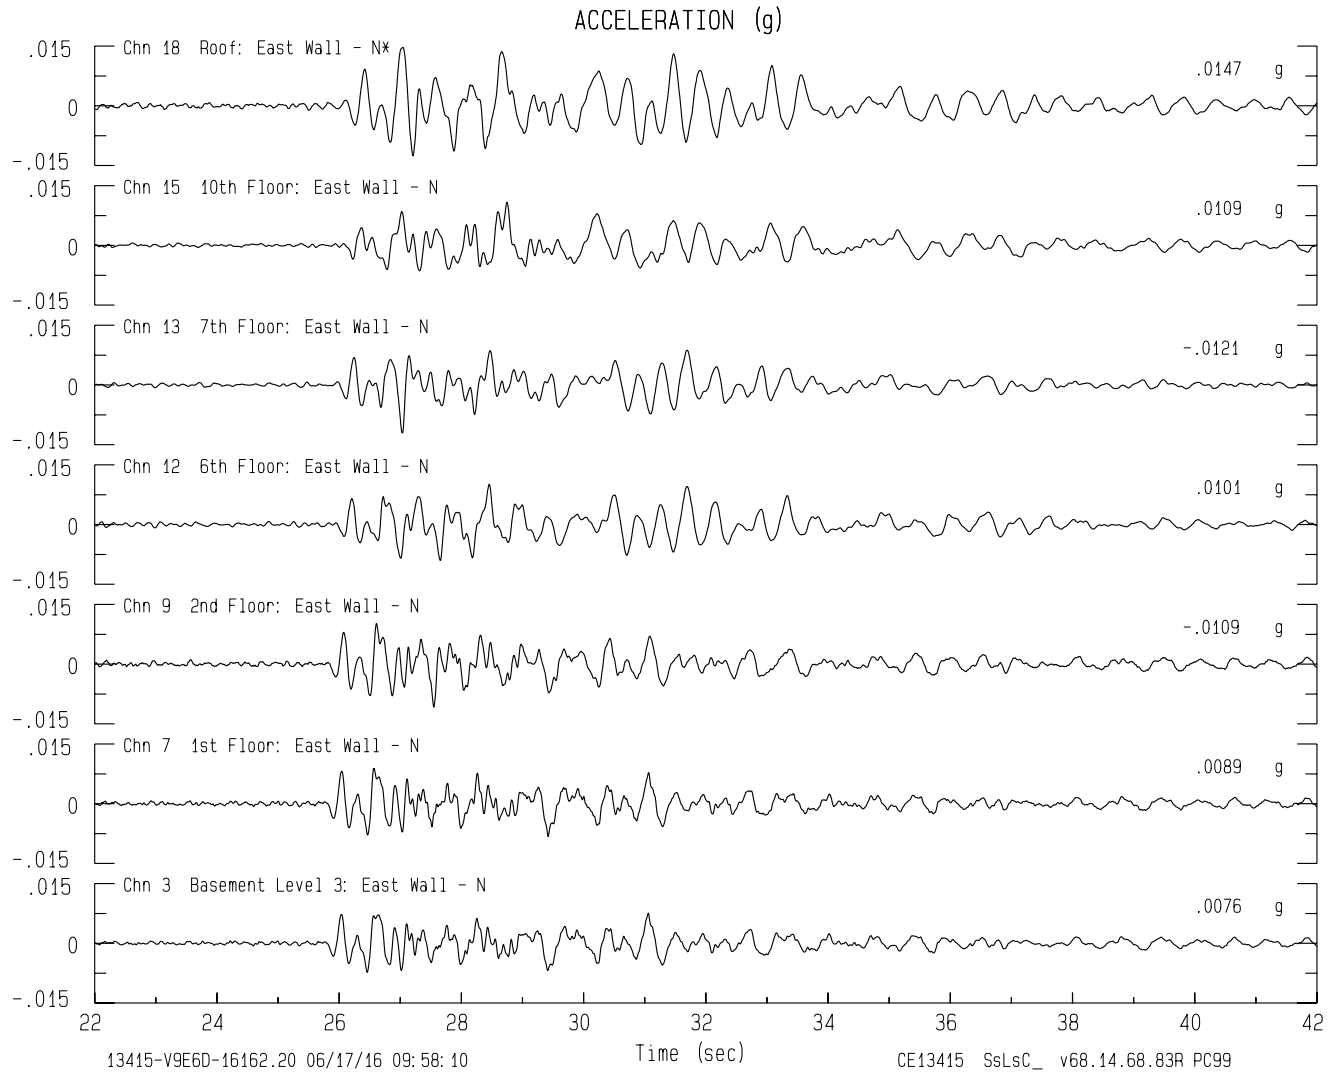
Riverside - 10-story Office Bldg CGS Sta 13415

Rc'd of Fri Jun 10, 2016 01:04:42.0 PDT

Frequency Band Processed: 3.3 secs to 40.0 Hz

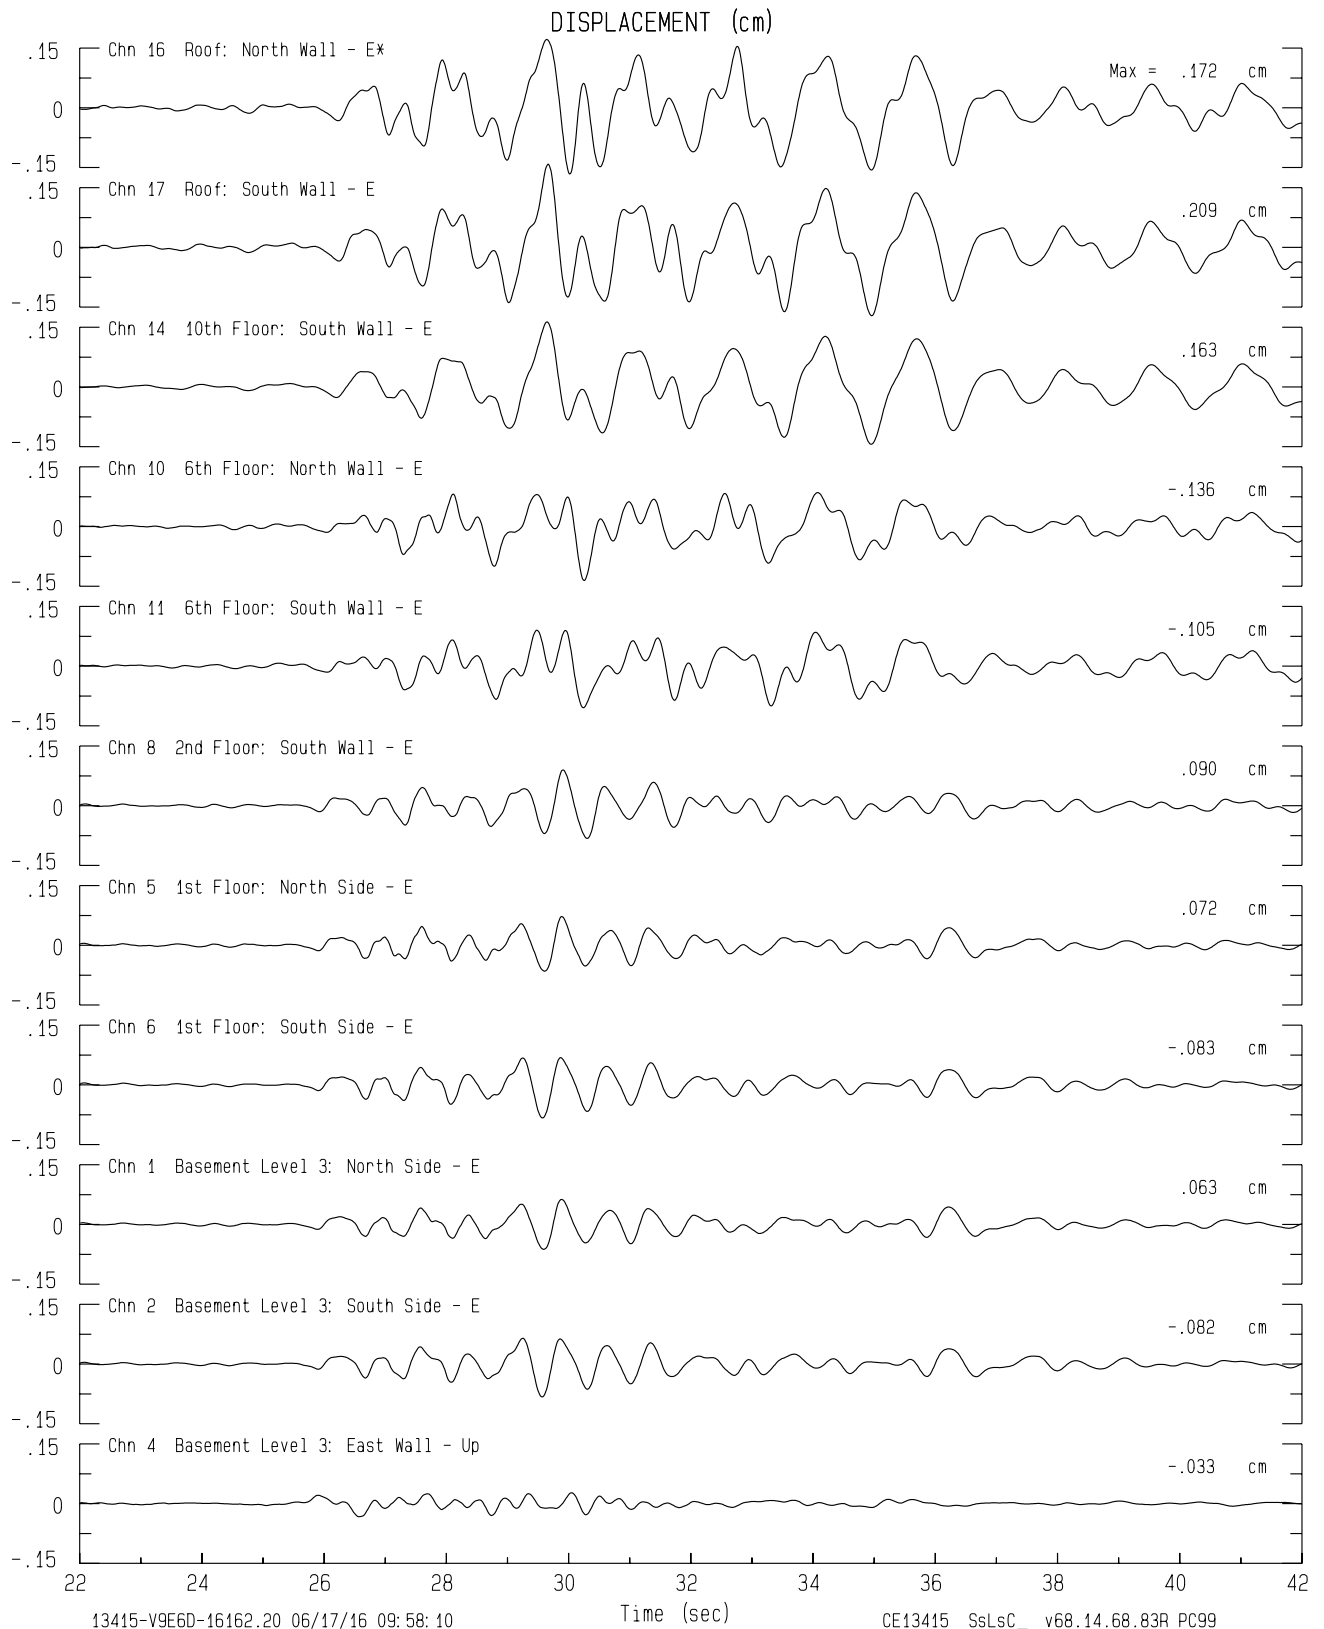
Riverside - 10-story Office Bldg CGS Sta 13415

Rc'd of Fri Jun 10, 2016 01:04:42.0 PDT

Frequency Band Processed: 3.3 secs to 40.0 Hz

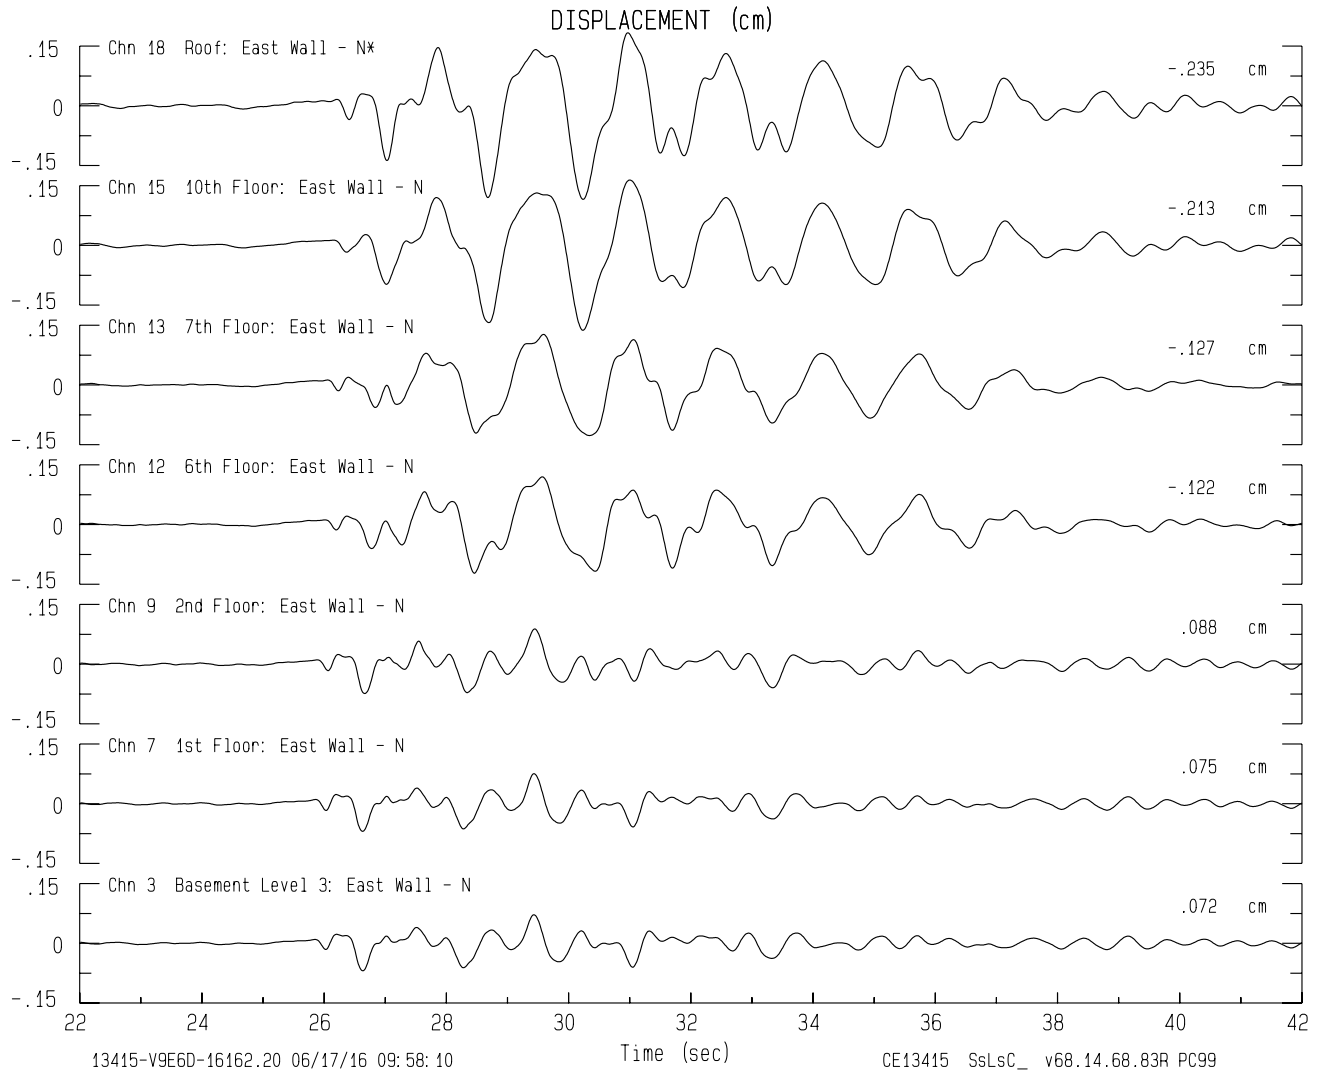
Riverside - 10-story Office Bldg CGS Sta 13415

Rcrd of Fri Jun 10, 2016 01:04:42.0 PDT

Frequency Band Processed: 3.3 secs to 40.0 Hz

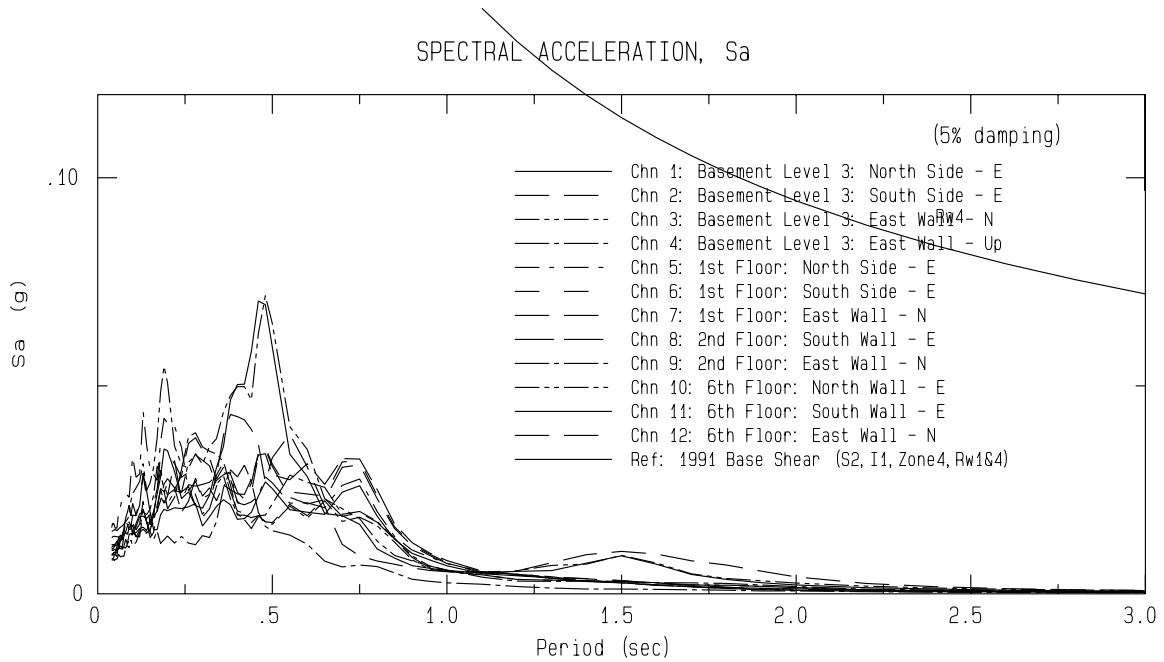
Riverside - 10-story Office Bldg CGS Sta 13415  
 Rcrd of Fri Jun 10, 2016 01:04:42.0 PDT  
 Frequency Band Processed: 3.3 secs to 40.0 Hz  
 Automated Strong Motion Processing - Preliminary and Subject to Revision

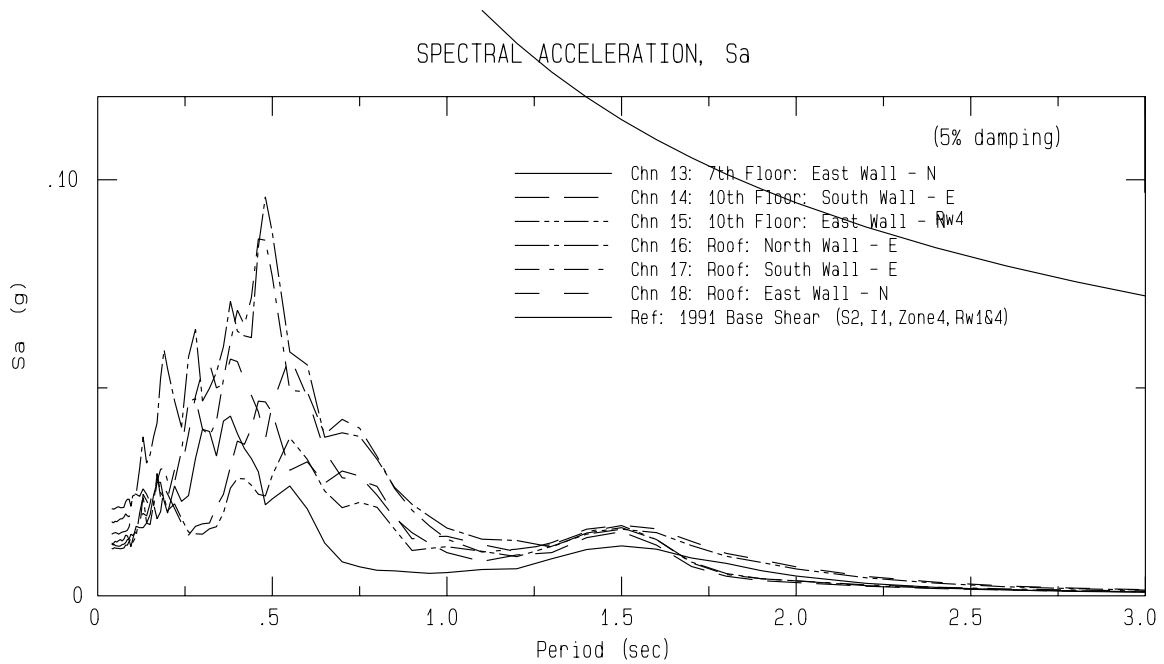
Riverside - 10-story Office Bldg CGS Sta 13415  
 Rcrd of Fri Jun 10, 2016 01:04:42.0 PDT  
 Frequency Band Processed: 3.3 secs to 40.0 Hz  
 Automated Strong Motion Processing - Preliminary and Subject to Revision
